REPORT ON FORD FIESTA TEST DRIVING

File: 1510685
March 31, 2017

2 Ford Fiesta Test Drive

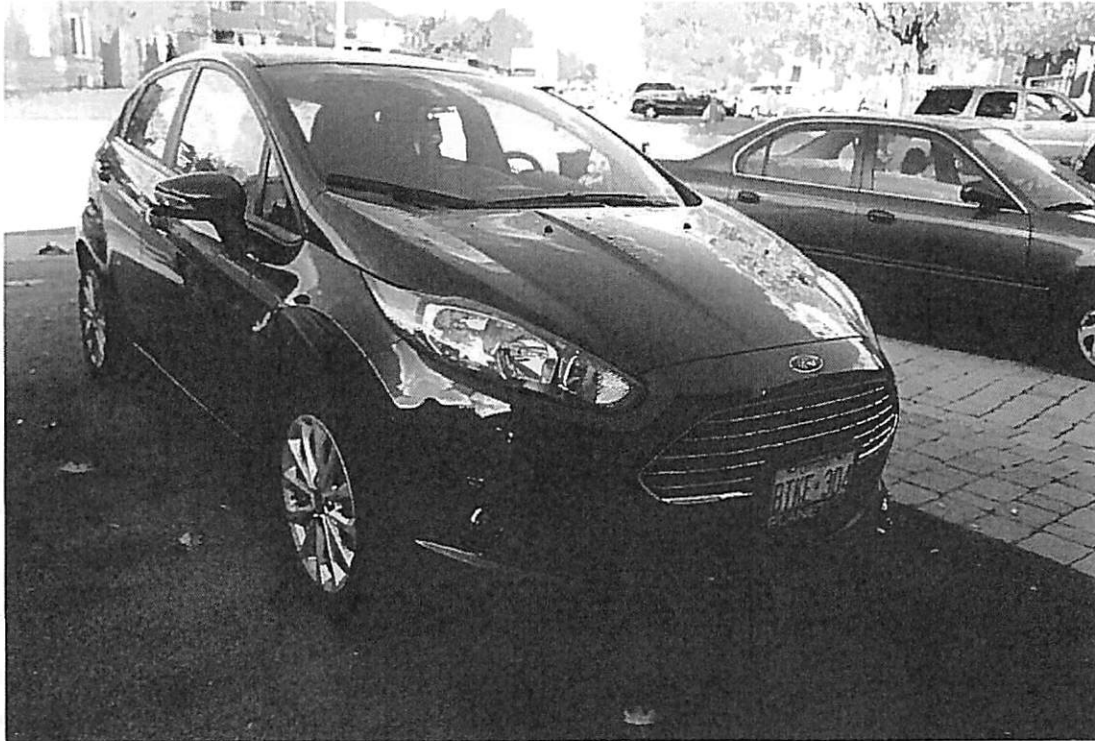
The Ford was a black, SE model Fiesta, 4 door hatchback manufactured on December 9, 2013. The vehicle identification number was 3FADP4EJ1EM143961. The odometer reading

was 38,046 kilometers. The automatic transmission included a Drive and Sport selection. Both selections were used during the test drive.

Figure 1: Ford Fiesta

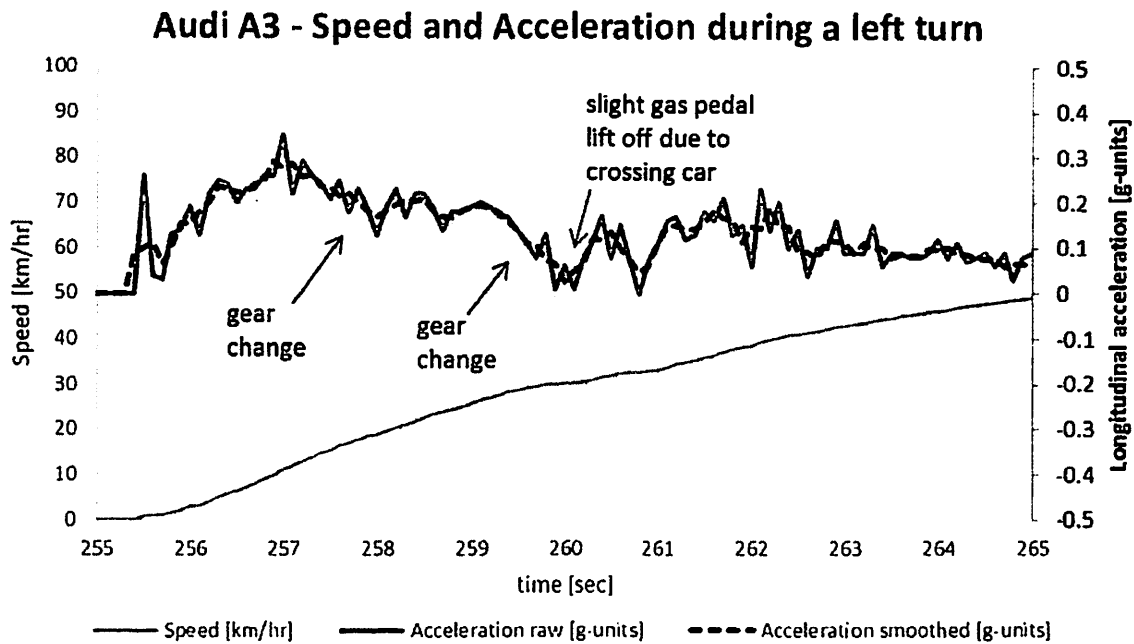
The comparison Audi A3's speed and acceleration profile during a similar left turn is illustrated in Figure 2 below. Video 2 in Appendix 2 further shows the comparison Audi A3 making a left turn. Compared to the Ford Fiesta, the Audi A3 did not exhibit the same sudden acceleration drop during its gear changes. The effect of gear changes were near negligible in the Audi. The Audi's changes in acceleration were generally smoother.

Figure 4 - Audi A3 Speed and Acceleration when starting a left turn

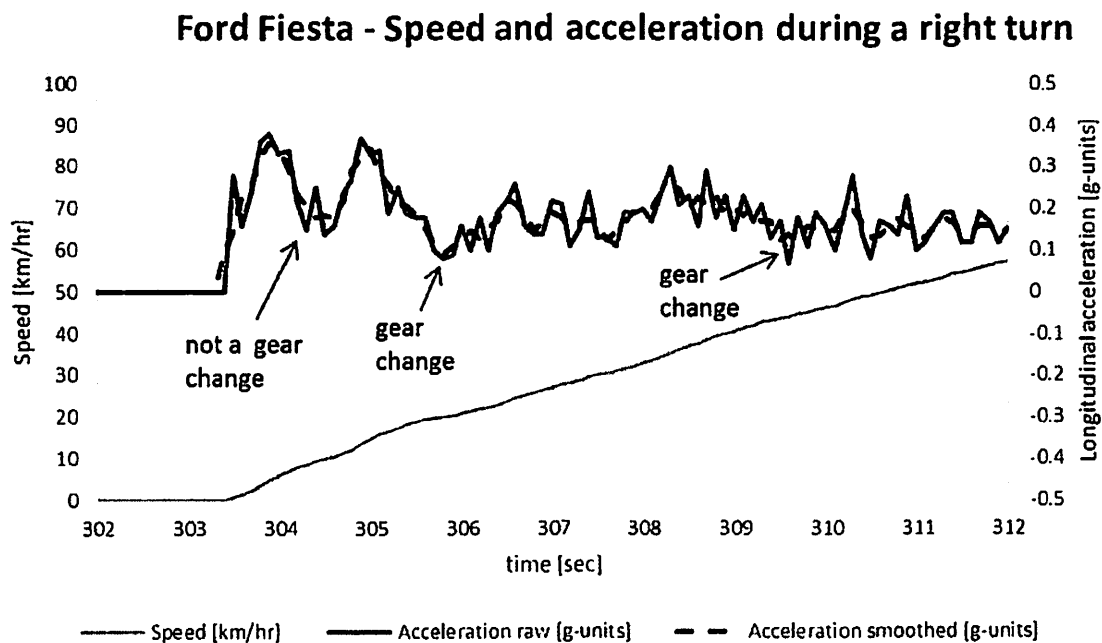
Figure 5 - Ford Fiesta Speed and Acceleration when starting a right turn

We found that, 0.8 seconds after initiating the right turn with the Ford Fiesta, it experienced a sudden acceleration drop, lasting 0.7 seconds. The Ford's acceleration decreased from 0.34 g-units to 0.14 g-units. This acceleration drop was not associated with a gear change. This was a common occurrence during our testing of the Ford Fiesta, when accelerating from a stop. No such acceleration drop was found with the Audi.

The Ford completed its right turn in 4.1 seconds. If the sudden acceleration drop had not occurred and if the Ford had maintained an acceleration rate of 0.34 g-units, then the Ford would have completed the right turn in 0.3 seconds faster. In instances where Ford Fiesta drivers are turning right to merge with through traffic, and expected to be able to complete a right turn, these drivers may instead be located 2.6 metres back from their intended location, due to the acceleration drop. This delay could further increase the risk for collision.
